## Test Report

**ANSI/CAN/UL9540A**

## Test Method for Evaluating Thermal Runaway Fire Propagation in Battery Energy Storage Systems [Unit Level]

**Test object / Model:** Lithium Ion Battery  
R-Bracket

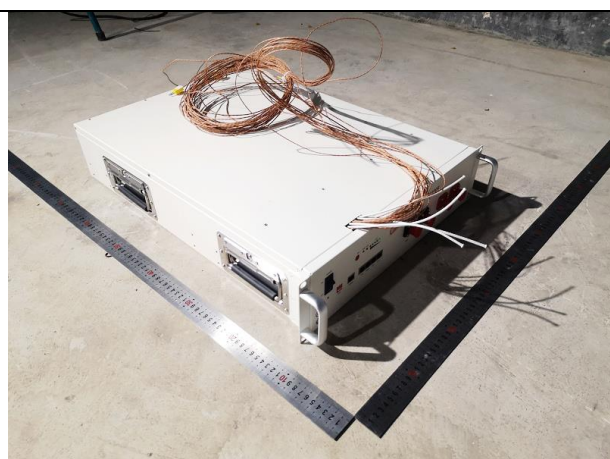
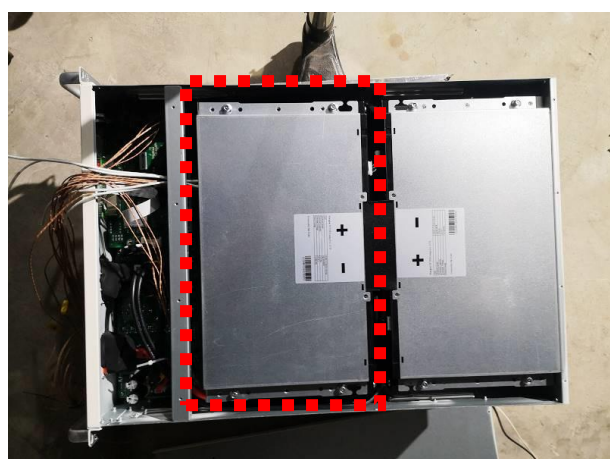
| <p>Initiation method:<br/> External heating method was used to initiate thermal runaway. 2 heaters were used to initiate thermal runaway. Heater 1 was placed between the large surfaces of Cell 2 and Cell 3. Heater 2 was placed between the large surfaces of Cell 3 and Cell 4. Cell 3 was selected as initiating cell. Each heater was connected to one voltage regulator.<br/> Heater 1 and Heater 2 were energized at the same time. The working currents of Heater 1 and Heater 2 were continuously adjusted to make sure that the initiating cell was heated at a ramp of 4-7 °C/min.</p> <p>Number of cells for initiating thermal runaway:<br/> <input checked="" type="checkbox"/> Single cell      100    Ah (total capacity)<br/> <input type="checkbox"/> Multiple cell      Ah (total capacity)</p> <p>Locations of cells for initiating thermal runaway: The initiating battery module consists of 2 submodules. Each submodule consists of 8 cells with a connection mode of 8S. Two submodules are connected in series. One 8S submodule (as shown in Figure 5c) is selected as the initiating submodule. heaters were placed on large face of cell 3. Cell 3 is selected as the initiating cell.</p> <p>Other description: N/A</p> |

Figure 5b. Internal schematic view of battery module.

Figure 5d. View of heater.

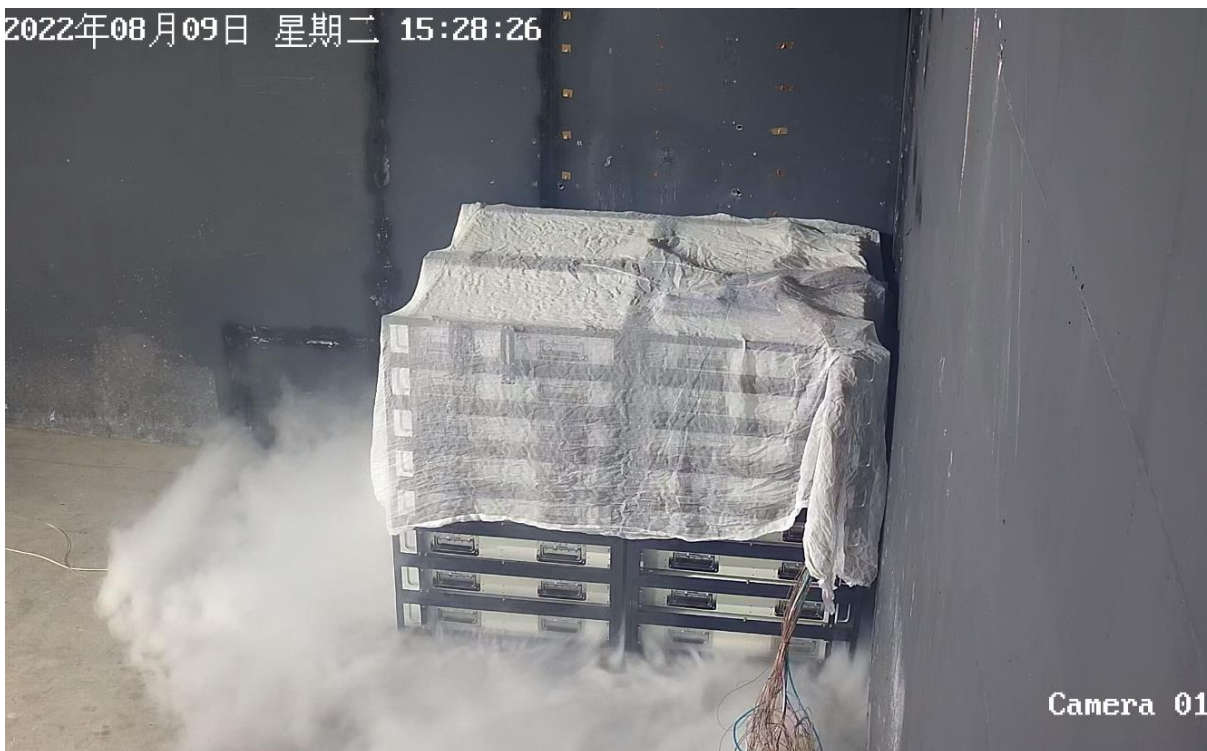
Figure 13. Photo 02 of initiating BESS unit and target BESS units during test.

| Time (HH: MM: SS) | Relative Time (HH: MM: SS) | Event ID | Event | Description | Photo Reference |
|---|---|---|---|---|---|
| 15:28:26 | 0:46:26 | E3 | Release | Smoke release observed from initiating battery system enclosure. | Figure 13 |

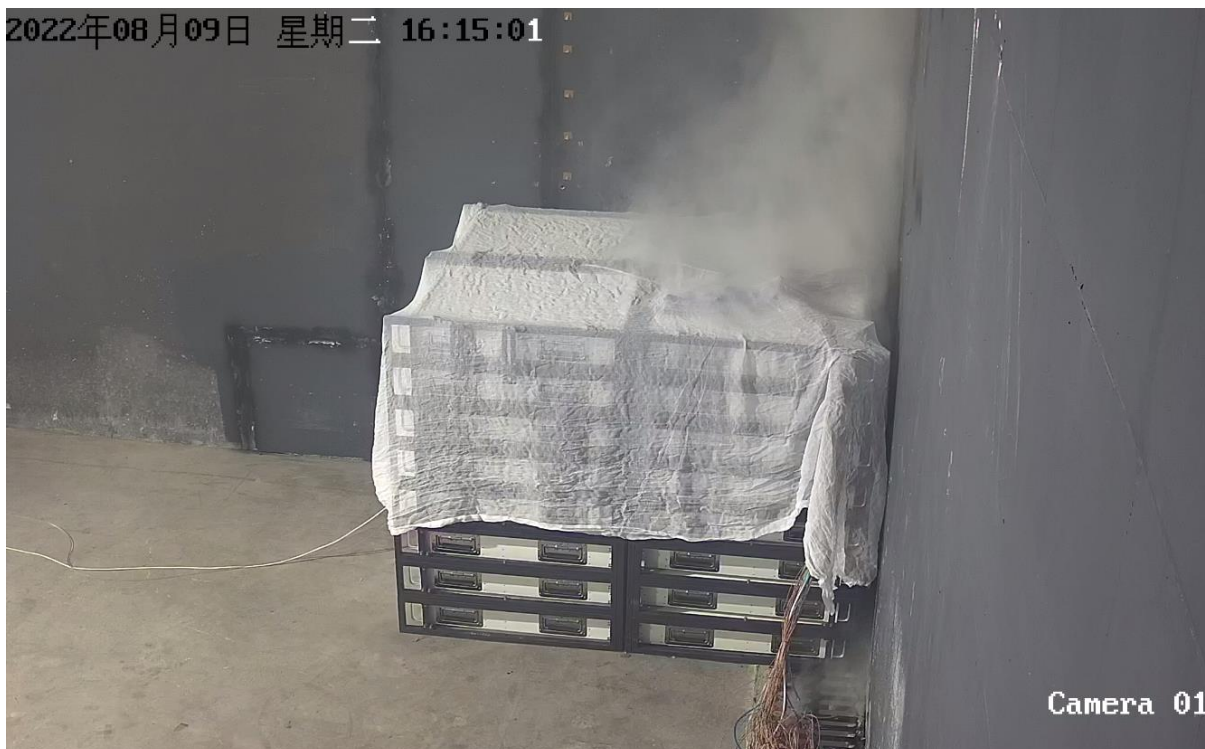
Figure 14. Photo 03 of initiating BESS unit and target BESS units during test.

| Time (HH: MM: SS) | Relative Time (HH: MM: SS) | Event ID | Event | Description | Photo Reference |
|---|---|---|---|---|---|
| 16:15:01 | 1:33:01 | E4 | Release | Smoke release observed from initiating battery system enclosure. | Figure 14 |

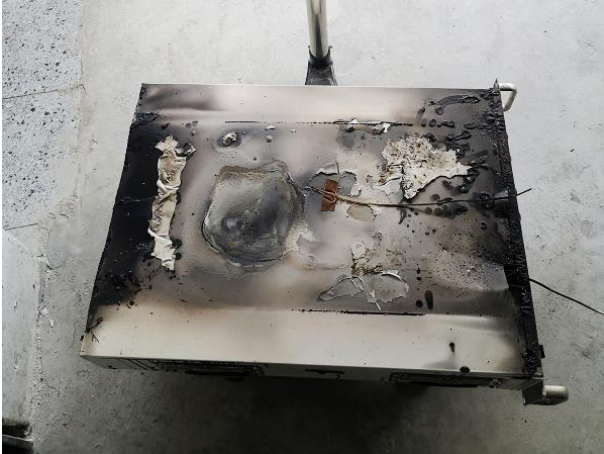
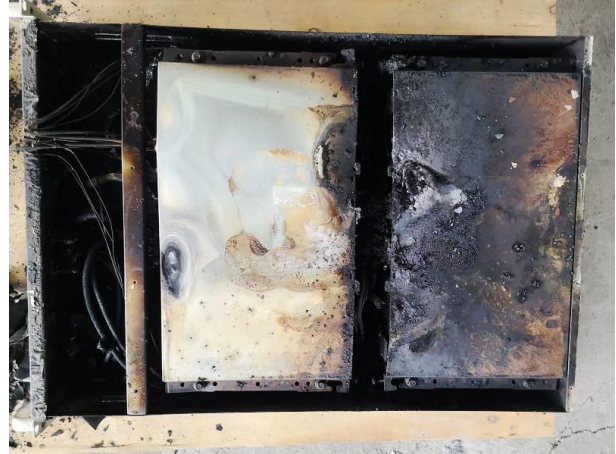
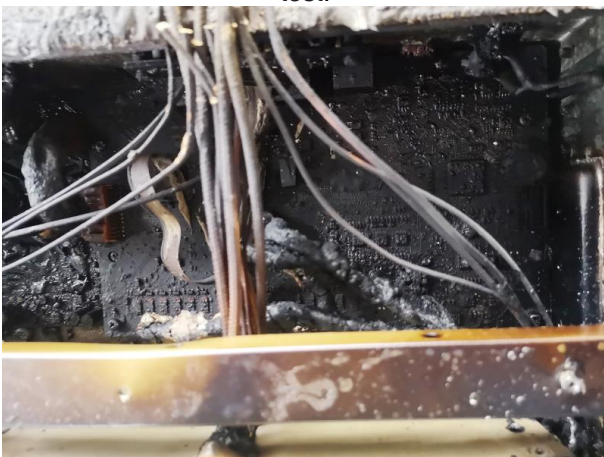
Figure 21a. Photo of initiating battery module after test.

Figure 21b. Photo 01 of thermal runaway location.

Figure 21c. Photo 02 of thermal runaway location.

Figure 21d. Photo 03 of thermal runaway location.

| Module ID | OCV of Battery Module Before Test, (V dc) | OCV of Battery Module After Test, (V dc) | Observation Results |
|---|---|---|---|
| Module 4 of initiatig unit | 53.320 | 0 | Gas and smoke venting observed. No external flaming observed. No flying debris observed. No explosion observed. |
